**SUSQUEHANNA RIVER BASIN
POLE RUN CREEK
SCHUYLKILL COUNTY**

**PENNSYLVANIA
NDS ID PA. 00686
DER ID 54-36**

POLE RUN DAM NO. 4

PHASE I INSPECTION REPORT NATIONAL DAM INSPECTION PROGRAM

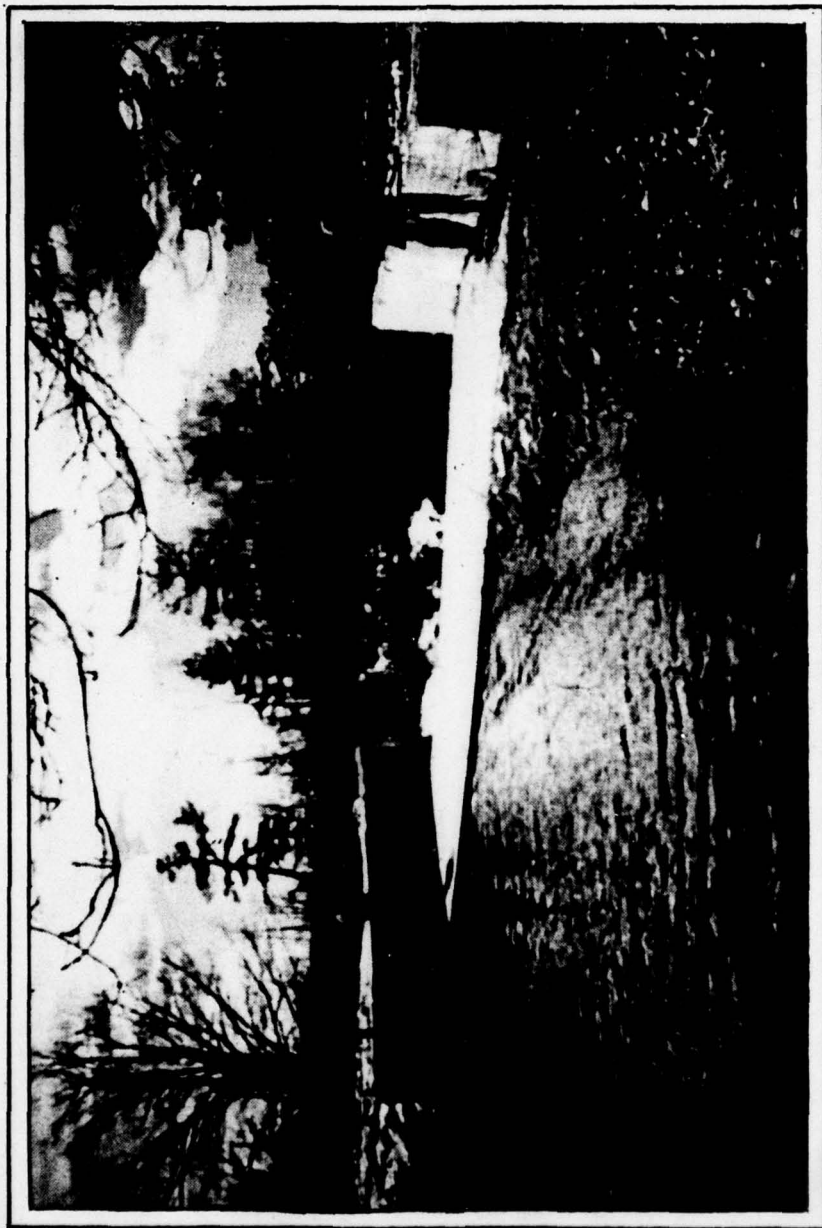
PHOTOGRAPH NO. 3

OVERVIEW OF EMERGENCY SPILLWAY.

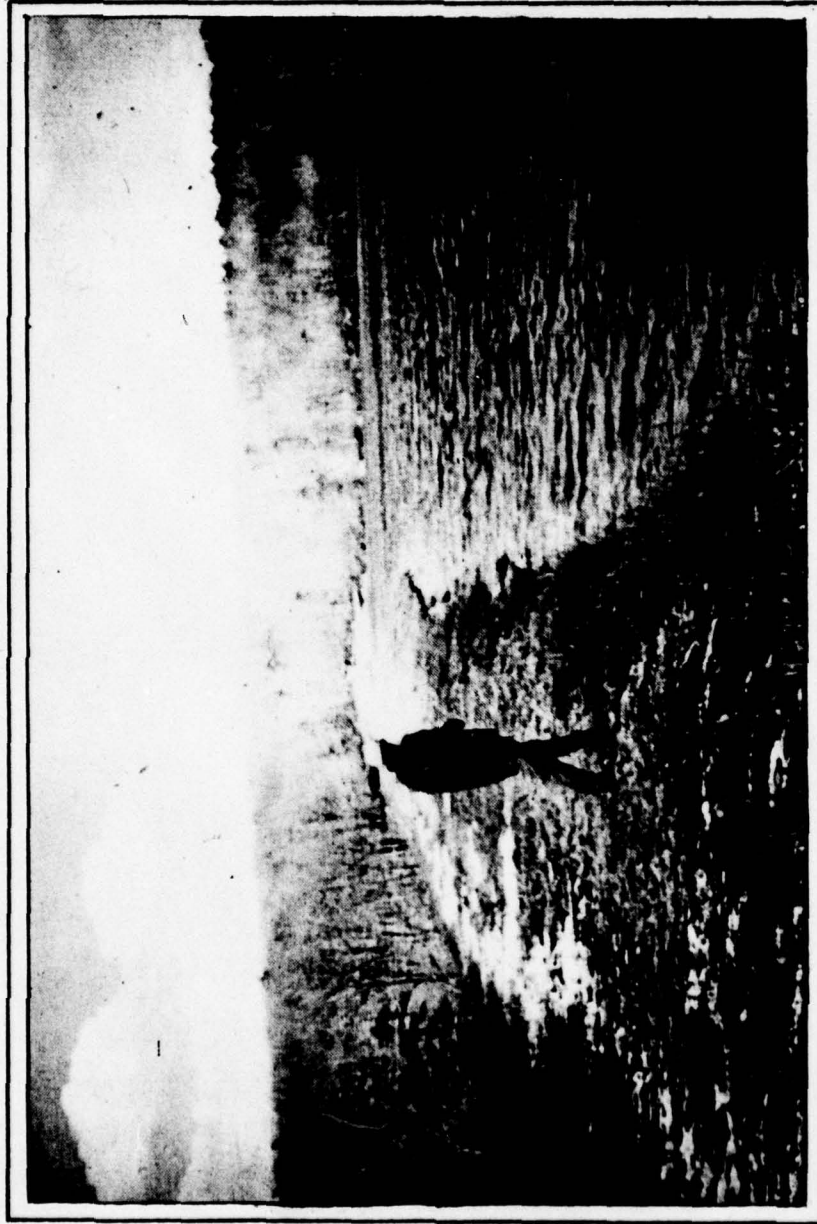
PHOTOGRAPH NO. 5

TYPICAL VIEW OF UPSTREAM SLOPE LOOKING
FROM THE LEFT END OF THE DAM.

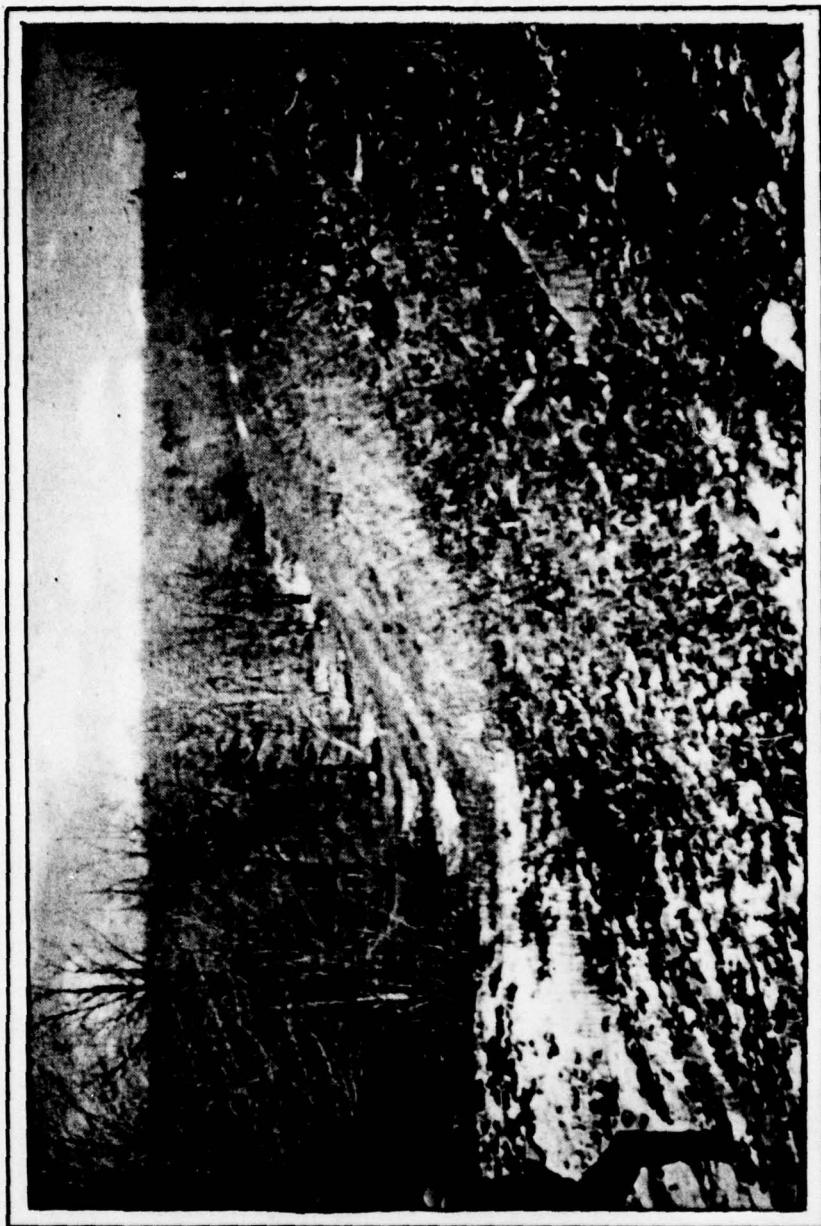
PHOTOGRAPH NO. 6

TYPICAL VIEW OF DOWNSTREAM SLOPE.

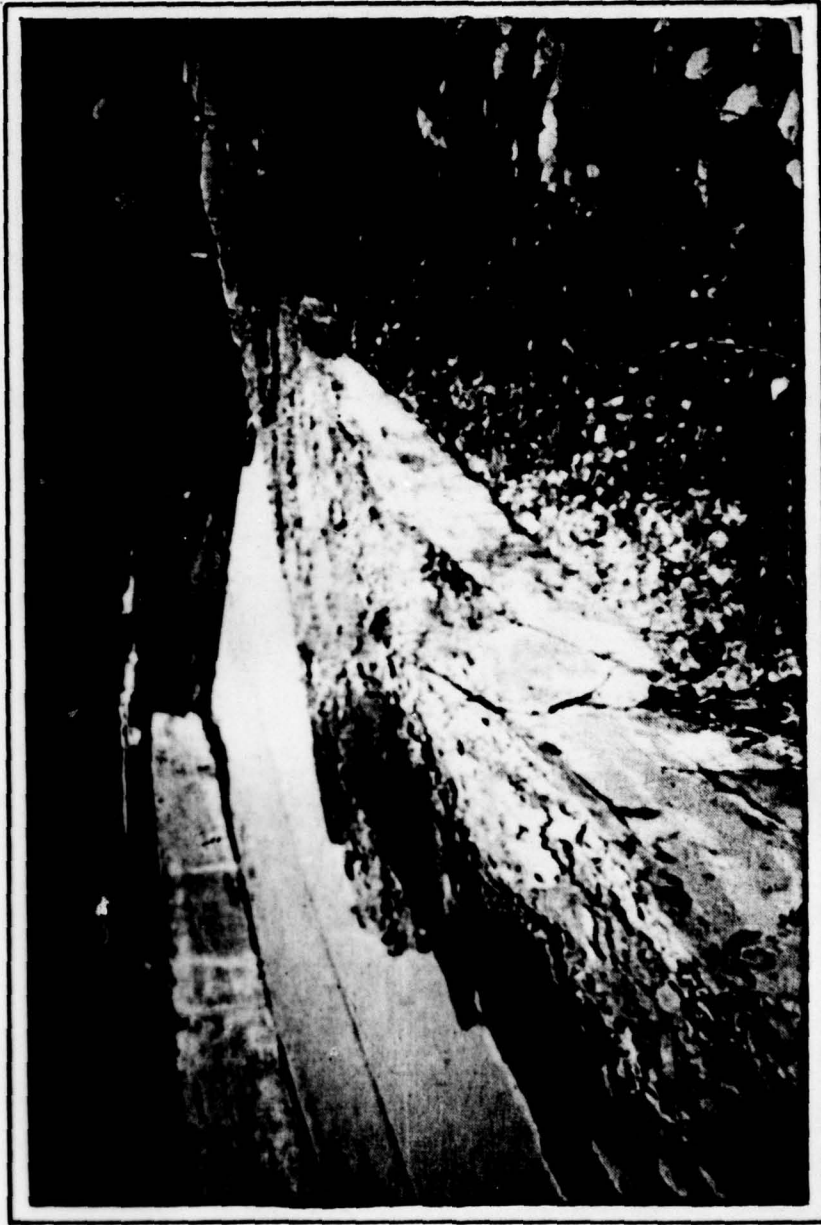
PHOTOGRAPH NO. 7

The concrete spillway is considered to be in fair condition, but the upstream wing wall is in poor condition. The concrete in several places is spalled and cracked and the upstream left retaining wall has cracked and has rotated upstream away from the channel side wall. The discharge channel below the spillway is in poor condition. Continued deterioration of the channel would most likely lead to undermining and possible failure of the spillway.

DETERIORATED SECTIONS OF CONCRETE
SPILLWAY WALLS

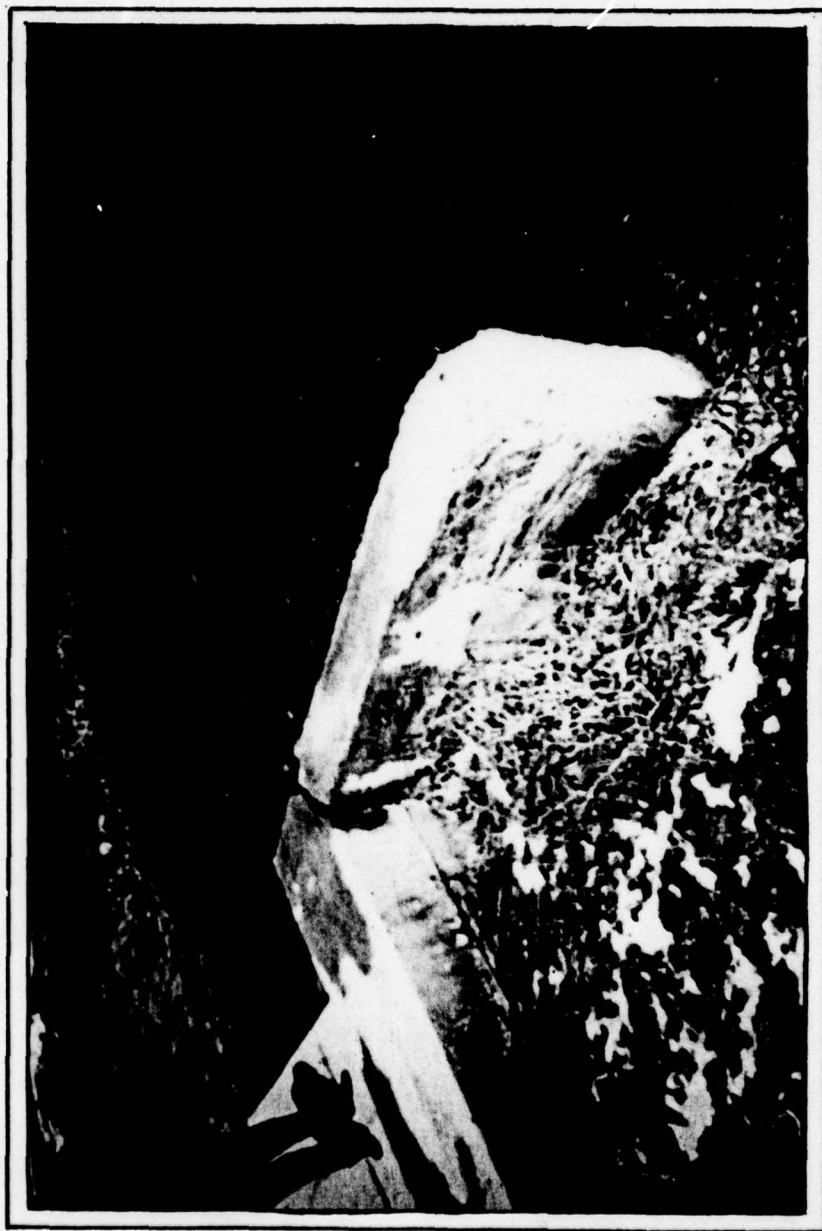
PHOTOGRAPH NO. 9

1. Spillway. The concrete discharge spillway and walls are assessed to be in fair condition with some cracking and spalling. The left headwall of the spillway has cracked and separated from the channel wall, rotating upstream. This section of wall is in poor condition. Railroad track has been installed in an attempt to restrain further movement. See Photograph 9. The channel immediately downstream of the spillway has been severely eroded; see Photograph 10 and Plate 5. The channel is only partially protected by large boulders and rocks.

DISPLACED UPSTREAM WINGWALL OF
EMERGENCY SPILLWAY.

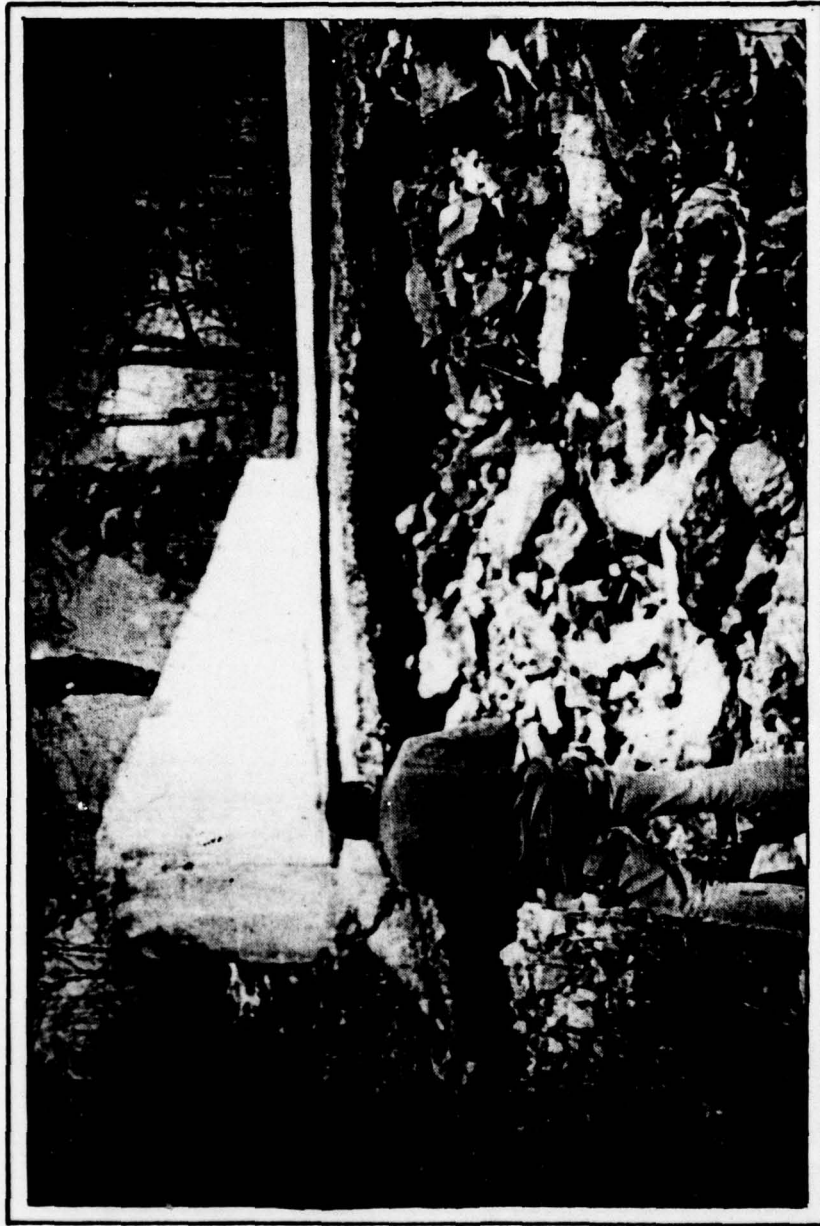
DISCHARGE CHANNEL	Poor condition. Significant portions of the channel have been eroded especially after Tropical Storm Agnes. There is an approximately 4-1/2 foot drop at the downstream edge of the discharge channel. See Plate 5, Appendix E.	
-------------------	---	--

DETERIORATED SPILLWAY DISCHARGE
CHANNEL. MOST DAMAGE REPORTEDLY
OCCURRED DURING TROPICAL STORM
AGNES.

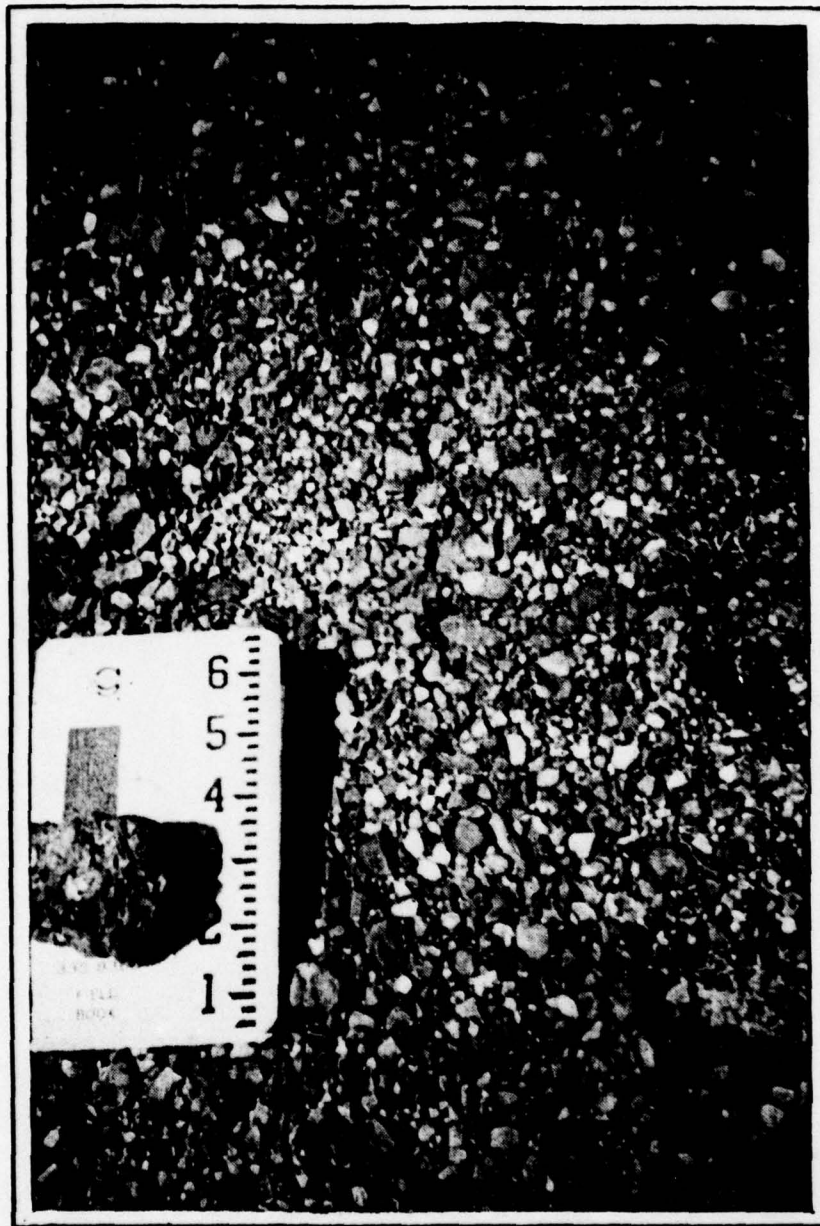
PHOTOGRAPH NO. 12

a. Visual Observations. Visual observations did not indicate an immediate embankment stability problem, but there is evidence of long-term downstream slope movements and longitudinal cracking along the crest. It is noted that this cracking may be attributed to the high water level with respect to the top of the embankment and recent freeze-thaw cycles which promote cracking.

TYPICAL LONGITUDINAL SURFACE
CRACK ALONG CREST OF DAM.

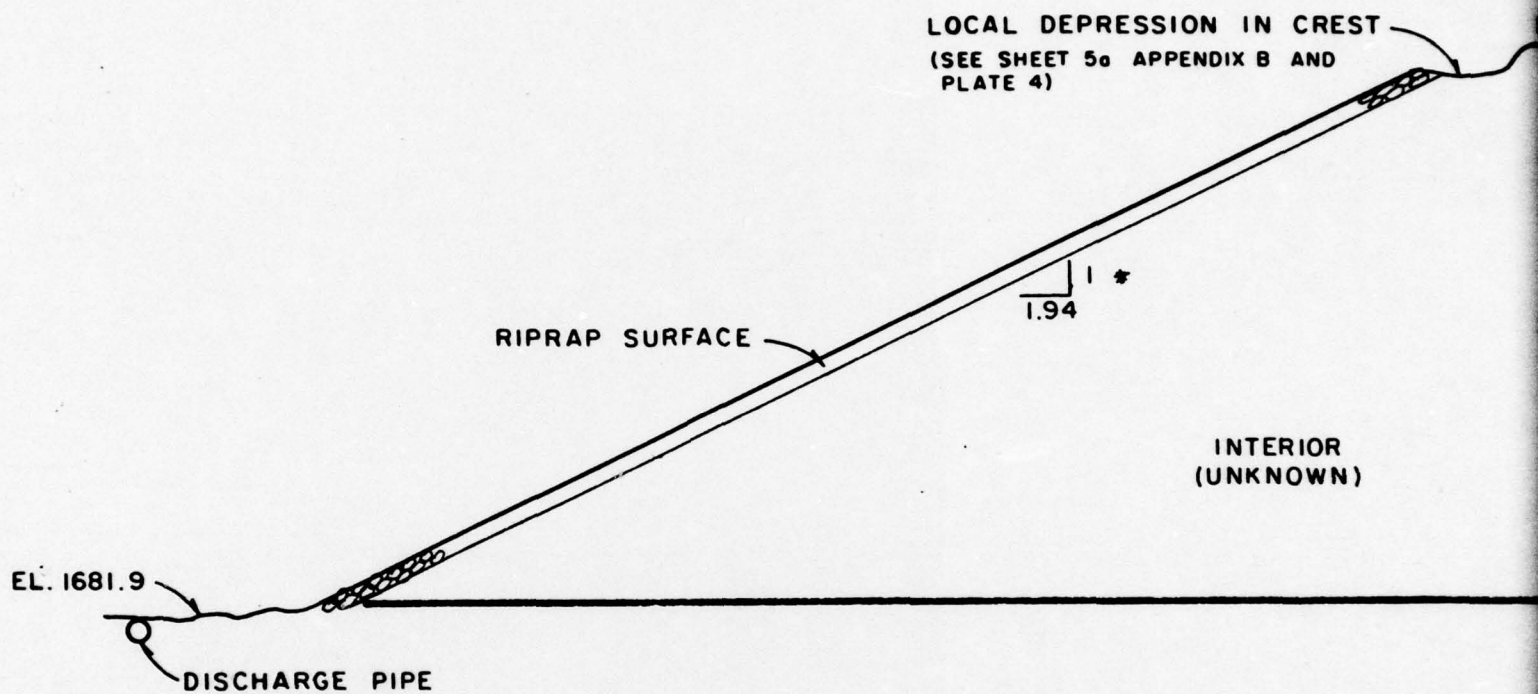
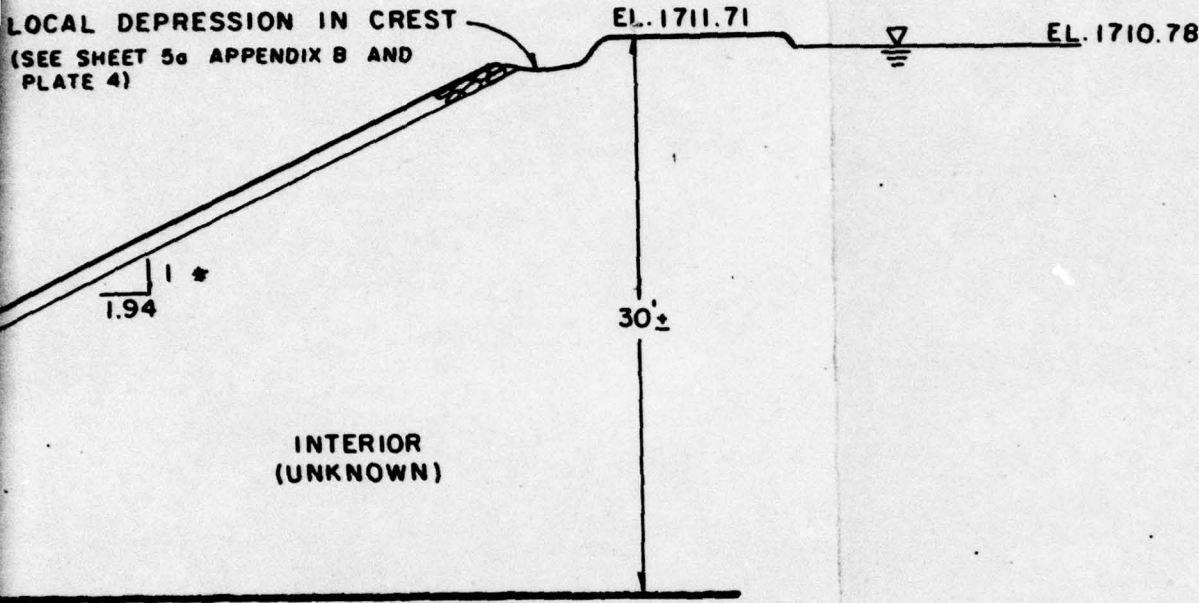
EMBANKMENT PROFILE	
POLE RUN DAM NO.4	
NAT.I.D.NO.PA.00886	SCHUYLKILL COUNTY
DATA OBTAINED FROM FIELD SURVEY, 10 APRIL, 1979	
PLATE 3

LOCAL DEPRESSION IN CREST
(SEE SHEET 5a APPENDIX B AND
PLATE 4)

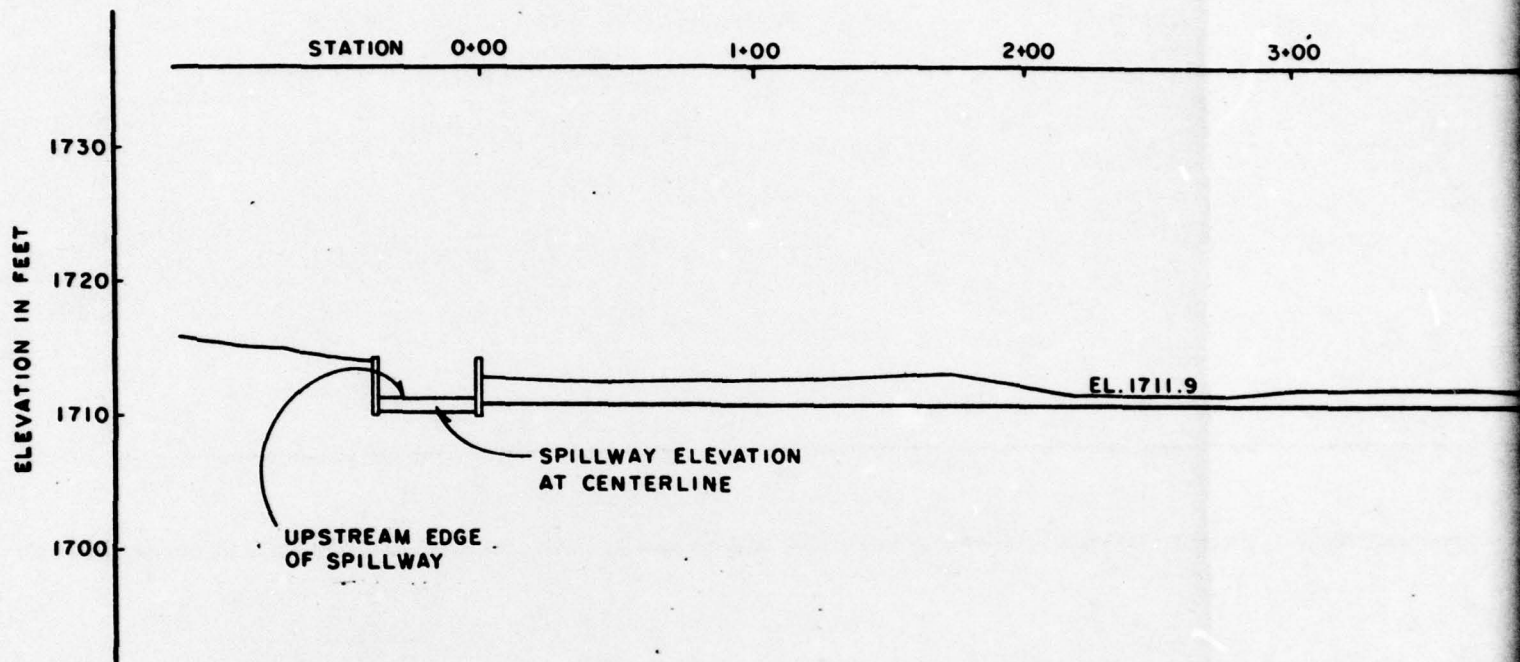
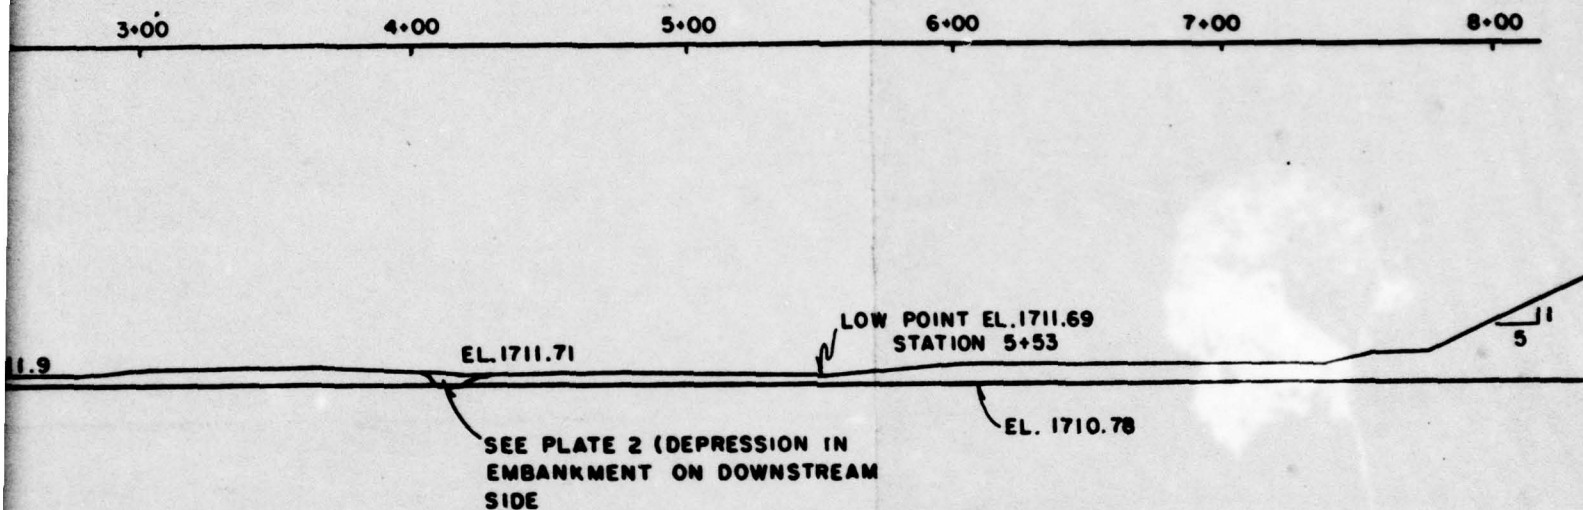
**LONGITUDINAL PROFILE OF CREST
POLE RUN DAM NO. 4**

b. Dam. The vertical alignment of the dam crest was checked and the profile is shown on Plate 4, Appendix E. The embankment is 0.4 feet below the left spillway wall and there is approximately seven inches of freeboard at normal pool. There was no discernible horizontal displacement or bulging noted along the crest, but slope undulations were prevalent along the full length of the dam. Longitudinal surface cracks were noted principally on the upstream side of the crest as shown on Sheet 5a and in Appendix D. These cracks appear to be surface cracks with no evidence found of embankment movement associated with them. Several small elliptical slope movements were noted near the toe, which appear to be scars from old shallow surface slides. Minor erosion was noted along the crest and at a few locations along the slope. One depressed area on the crest, as shown on Sheet 5a, appears to have resulted from concentrated surface runoff passing over the downstream slope.

c. Visual Observations. The only condition disclosed by the inspection that limits spillway capacity is the very small distance between the reservoir surface and the top of the dam, as shown on Plate 4, Appendix E. Other observations regarding the condition of the downstream channel, spillway and reservoir are located in Appendix B.

VISUAL EXAMINATION OF	OBSERVATIONS	REMARKS OR RECOMMENDATIONS
SURFACE CRACKS	<p>Yes. Horizontal surface cracks were noted mostly on the upstream side of the crest as shown on Sheet 5a, and in Appendix D. They appear to be surface cracks and there was no evidence found of embankment movement associated with these cracks.</p>	
UNUSUAL MOVEMENT OR CRACKING AT OR BEYOND THE TOE	<p>None observed but several small elliptical areas along the downstream toe were observed which appear to be scars of old shallow surface slides.</p>	
SLOUGHING OR EROSION OF EMBANKMENT AND ABUTMENT SLOPES	<p>Minor erosion was noted along the crest and at a few locations along the slope. One depressed area as shown on Sheet 5a, appears to be a place where surface runoff concentrates before passing over the downstream slope.</p>	
VERTICAL AND HORIZONTAL ALIGNMENT OF THE CREST	<p>Horizontal alignment appears to be good with no significant deviation when compared to old photographs. The vertical alignment undulates as shown on Plate 4, Appendix E.</p>
